Wellsite and Access Road Inspection for CoR Part 2

A wellsite and an access road located in a remote area and were built with minimum disturbance.

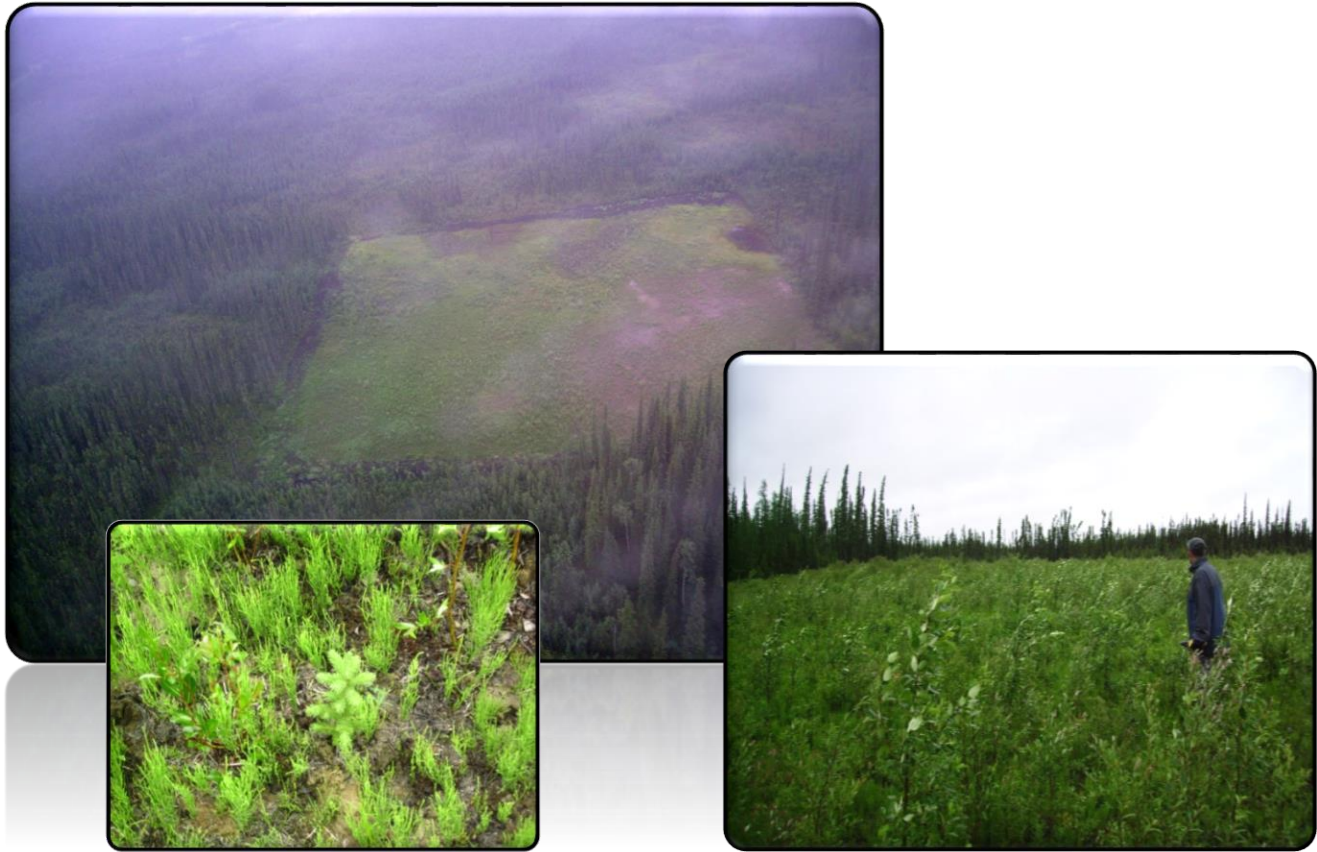
The site displayed surface roughness and featured woody debris and slash piles along the perimeter of the wellsite.

The vegetation cover established within the cleared areas was at a seral stage that led to a desirable climax plant community. The soil assessment concluded that surface compaction did not result from the operator's activities on site. We recommended leaving the woody debris and slash piles along the perimeter as they acted as propagation beds for the softwood species surrounding the disturbance.
